GUIDED WAVE ULTRASONIC INSPECTION FOR ROAD CROSSING PIPELINES

**NDT Inspector
Shuaiba Refinery
Kuwait National Petroleum Company
Kuwait
Email: nae015@knpc.co.kw**

INSPECTION & CORROSION DIV.
SHU REFINERY

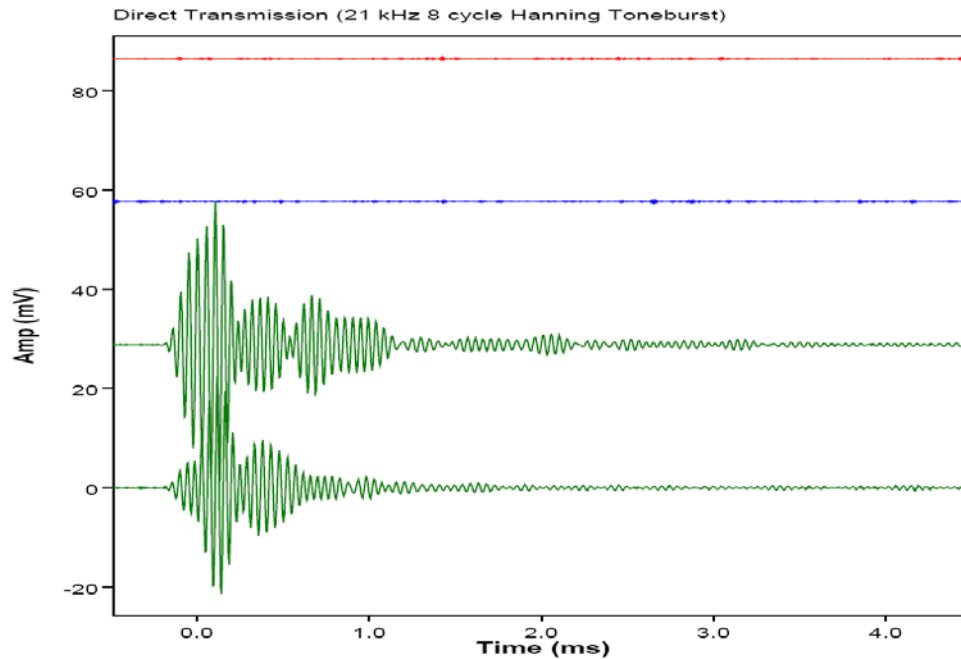
Figure 01

Green Signal (in figure 01): This is the signal as transmitted from one row to next row. It is used to measure how efficiently energy is coupled into the pipe.

Blue Line (in figure 01): This signal is used to determine the amount of error expected in the measurement related to signal size on the green trace.

Red Line (in figure 01): This signal is received by the transducer when the equipment is not transmitting and this represents the noise in the pipe that has been created by other sources.

The Equipment automatically samples three calibration signals with each data collection. This data allows various parameters, such as the true signal to ambient noise ratio to be determined. (Figure-03)

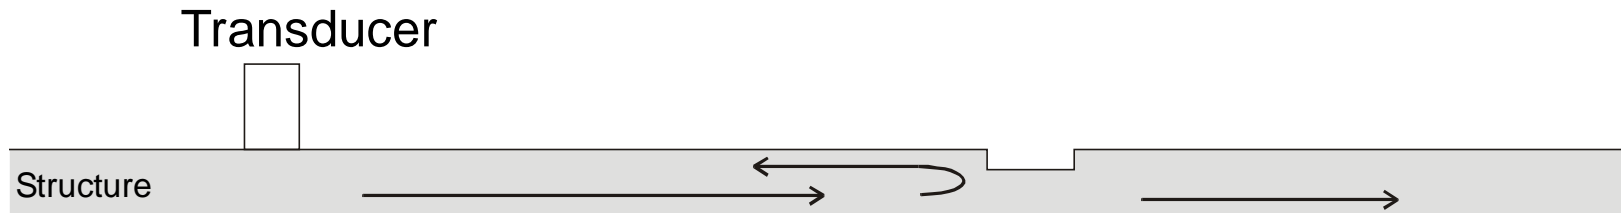
The change in cross section due to thickness loss, weld profile, welded/normal supports and pipe features will cause reflection of GW. The reflection is detected by the transducer and sent to the computer.

Schematic of wave Behavior in the presence of a wall loss

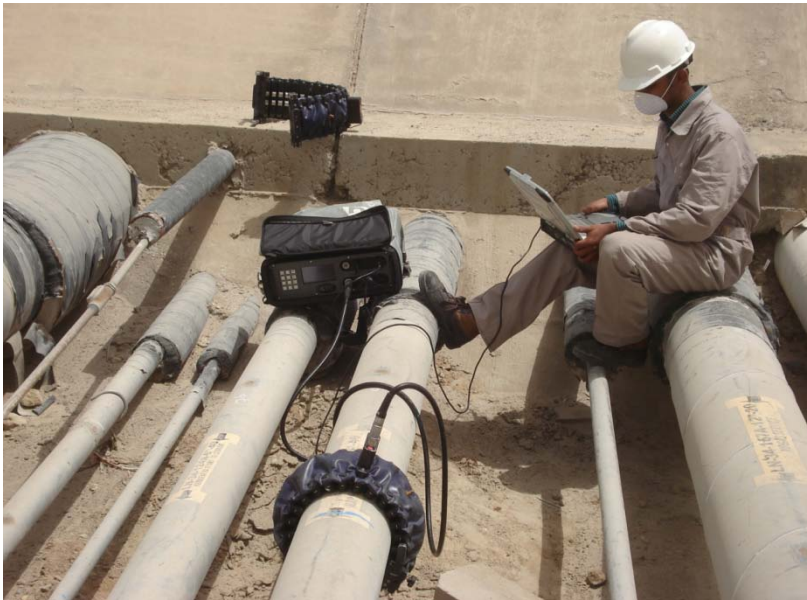
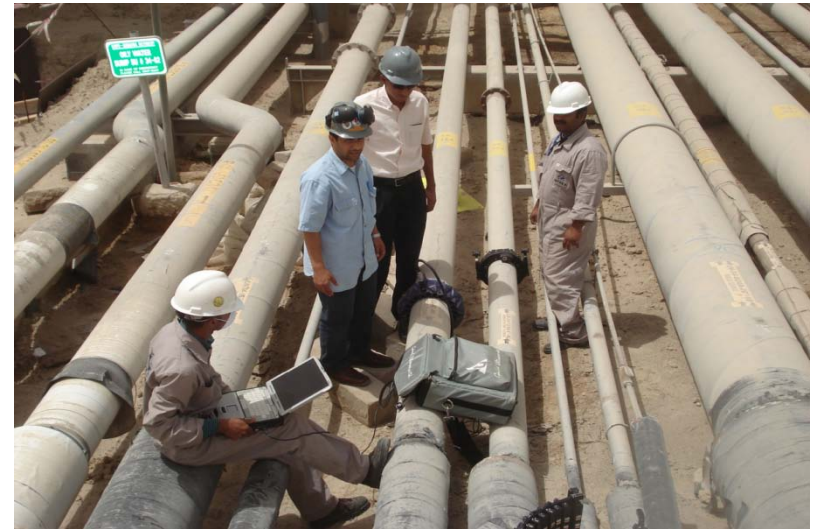
Typical Arrangement of Guided wave System

**Photographs
(Showing G3 Guided Ultrasonic Equipment)**

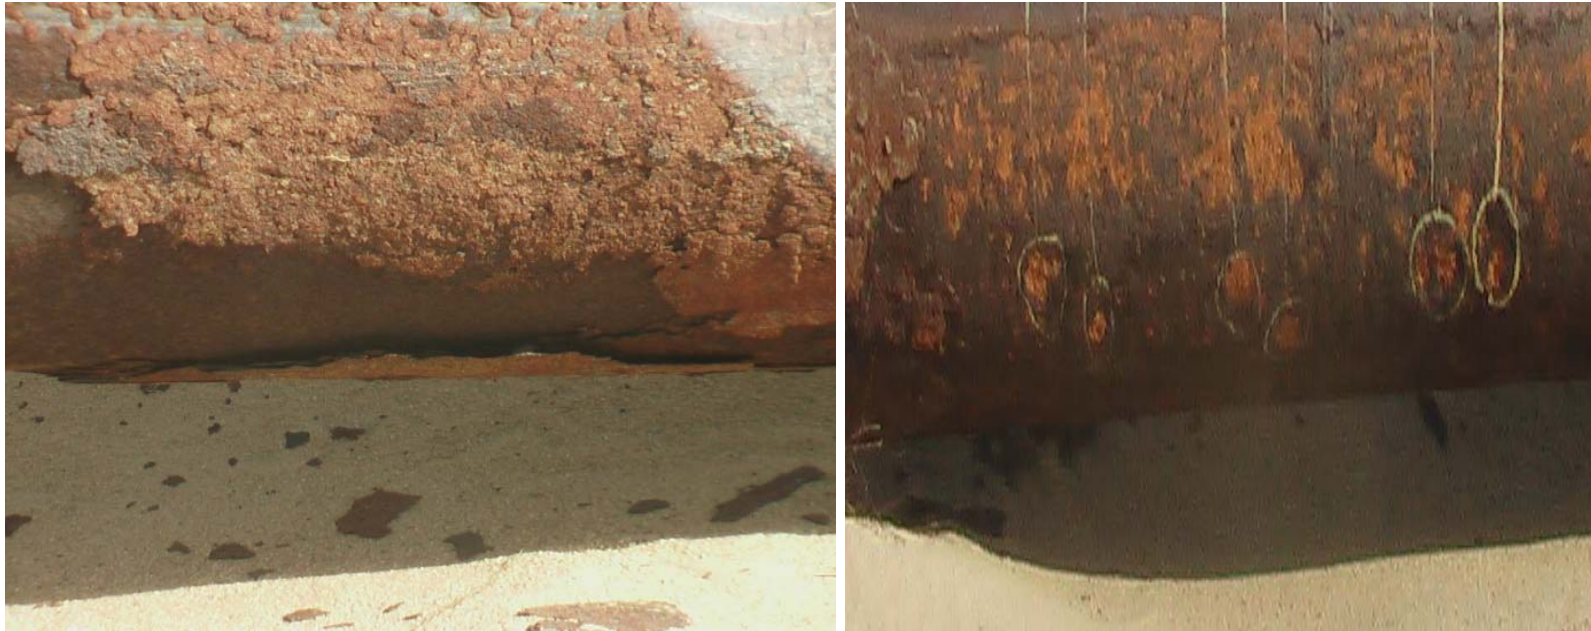
CASE STUDY – 02 (PICTURE)

Severe external corrosion observed just outside the sleeve as well as inside the sleeve area. Minimum thickness measured was 5.6mm of original 9.5mm
